## CONCRETE PRESSURE PIPE IN EARTHQUAKE ZONES

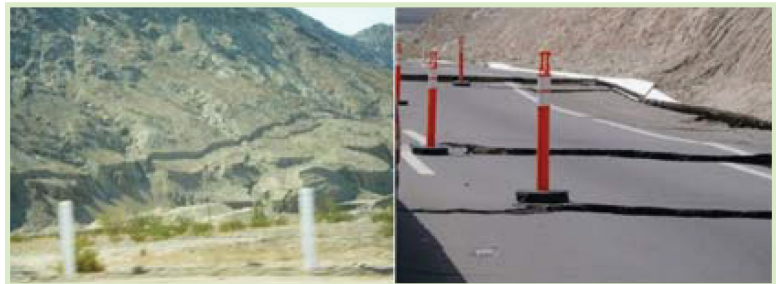
*Figure 1. Extensive damage (right picture) to the Mexicali-to-Tijuana Highway at kilometer 20 at the Laguna Salada Fault Crossing. The fault line can be observed in the left picture. A 60" PCCP line with gasketed joints is installed parallel to this highway. The PCCP was inspected by potholing several locations and found to be undamaged.*

Three case studies of concrete pressure pipelines inspected after large earthquakes in California and northwestern Mexico demonstrate the excellent performance of concrete pressure pipe with ordinary gasket joints. These studies were presented in the paper, "Review of Performance of Gasketed Joints of Buried Concrete and Steel Pipelines in California After Recent Seismic Events," at the ASCE Pipelines 2011 Conference.<sup>1</sup> As an example, a 60" PCCP line immediately adjacent to the fault which caused the damage shown in Figure 1 was examined after the earthquake and found to be undamaged.
